City of Alexandria Storm Sewer Capacity Analysis (CASSCA)

Four Mile Run Condition Assessment

PREPARED FOR: City of Alexandria, CH2M Hill
PREPARED BY: Baker
DATE: January 4, 2013 (Revised May 26, 2015)

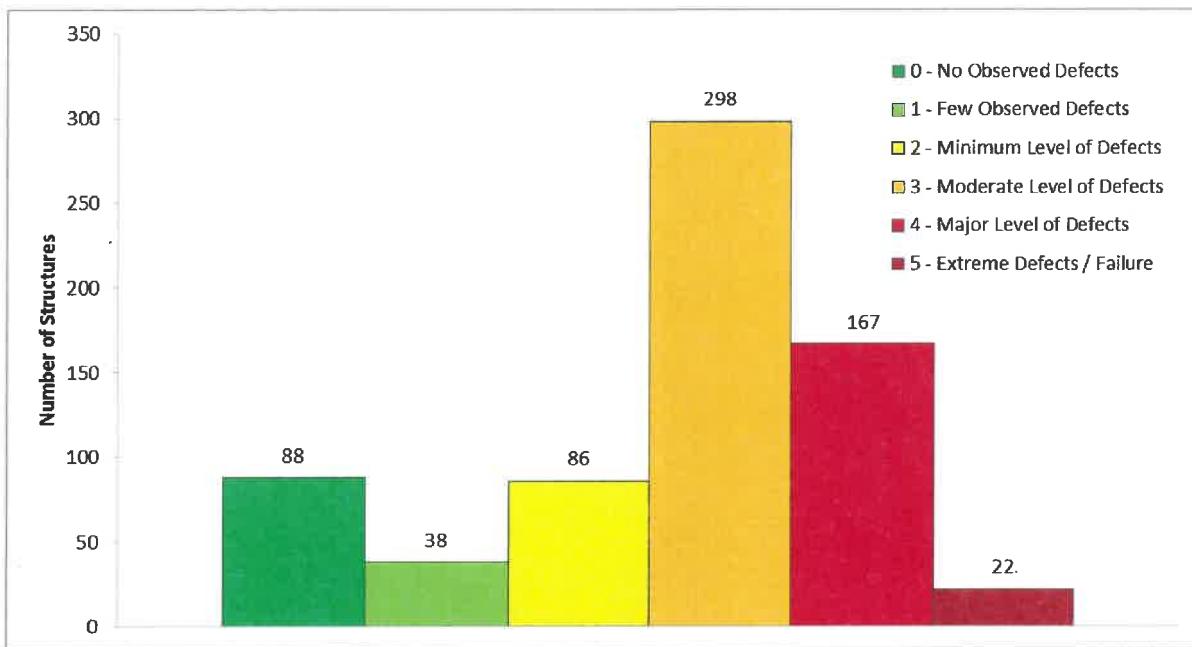
Figure 1. Structure Inspection Summary.

Figure 1 is a summary of the inspection results by severity of structure condition score. Figure 2 is provided to show the location of each structure within the Four Mile Run watershed, color coded to the defect categories listed above. The average condition score of 699 storm structures inspected within the Four Mile Run watershed was 45 (Moderate). Approximately 27% had scores 61 or higher, placing them in the major and extreme categories. About 18% of the structures showed few to no defects, while the remaining 55% of structures ranked in the medium to moderate defect categories.

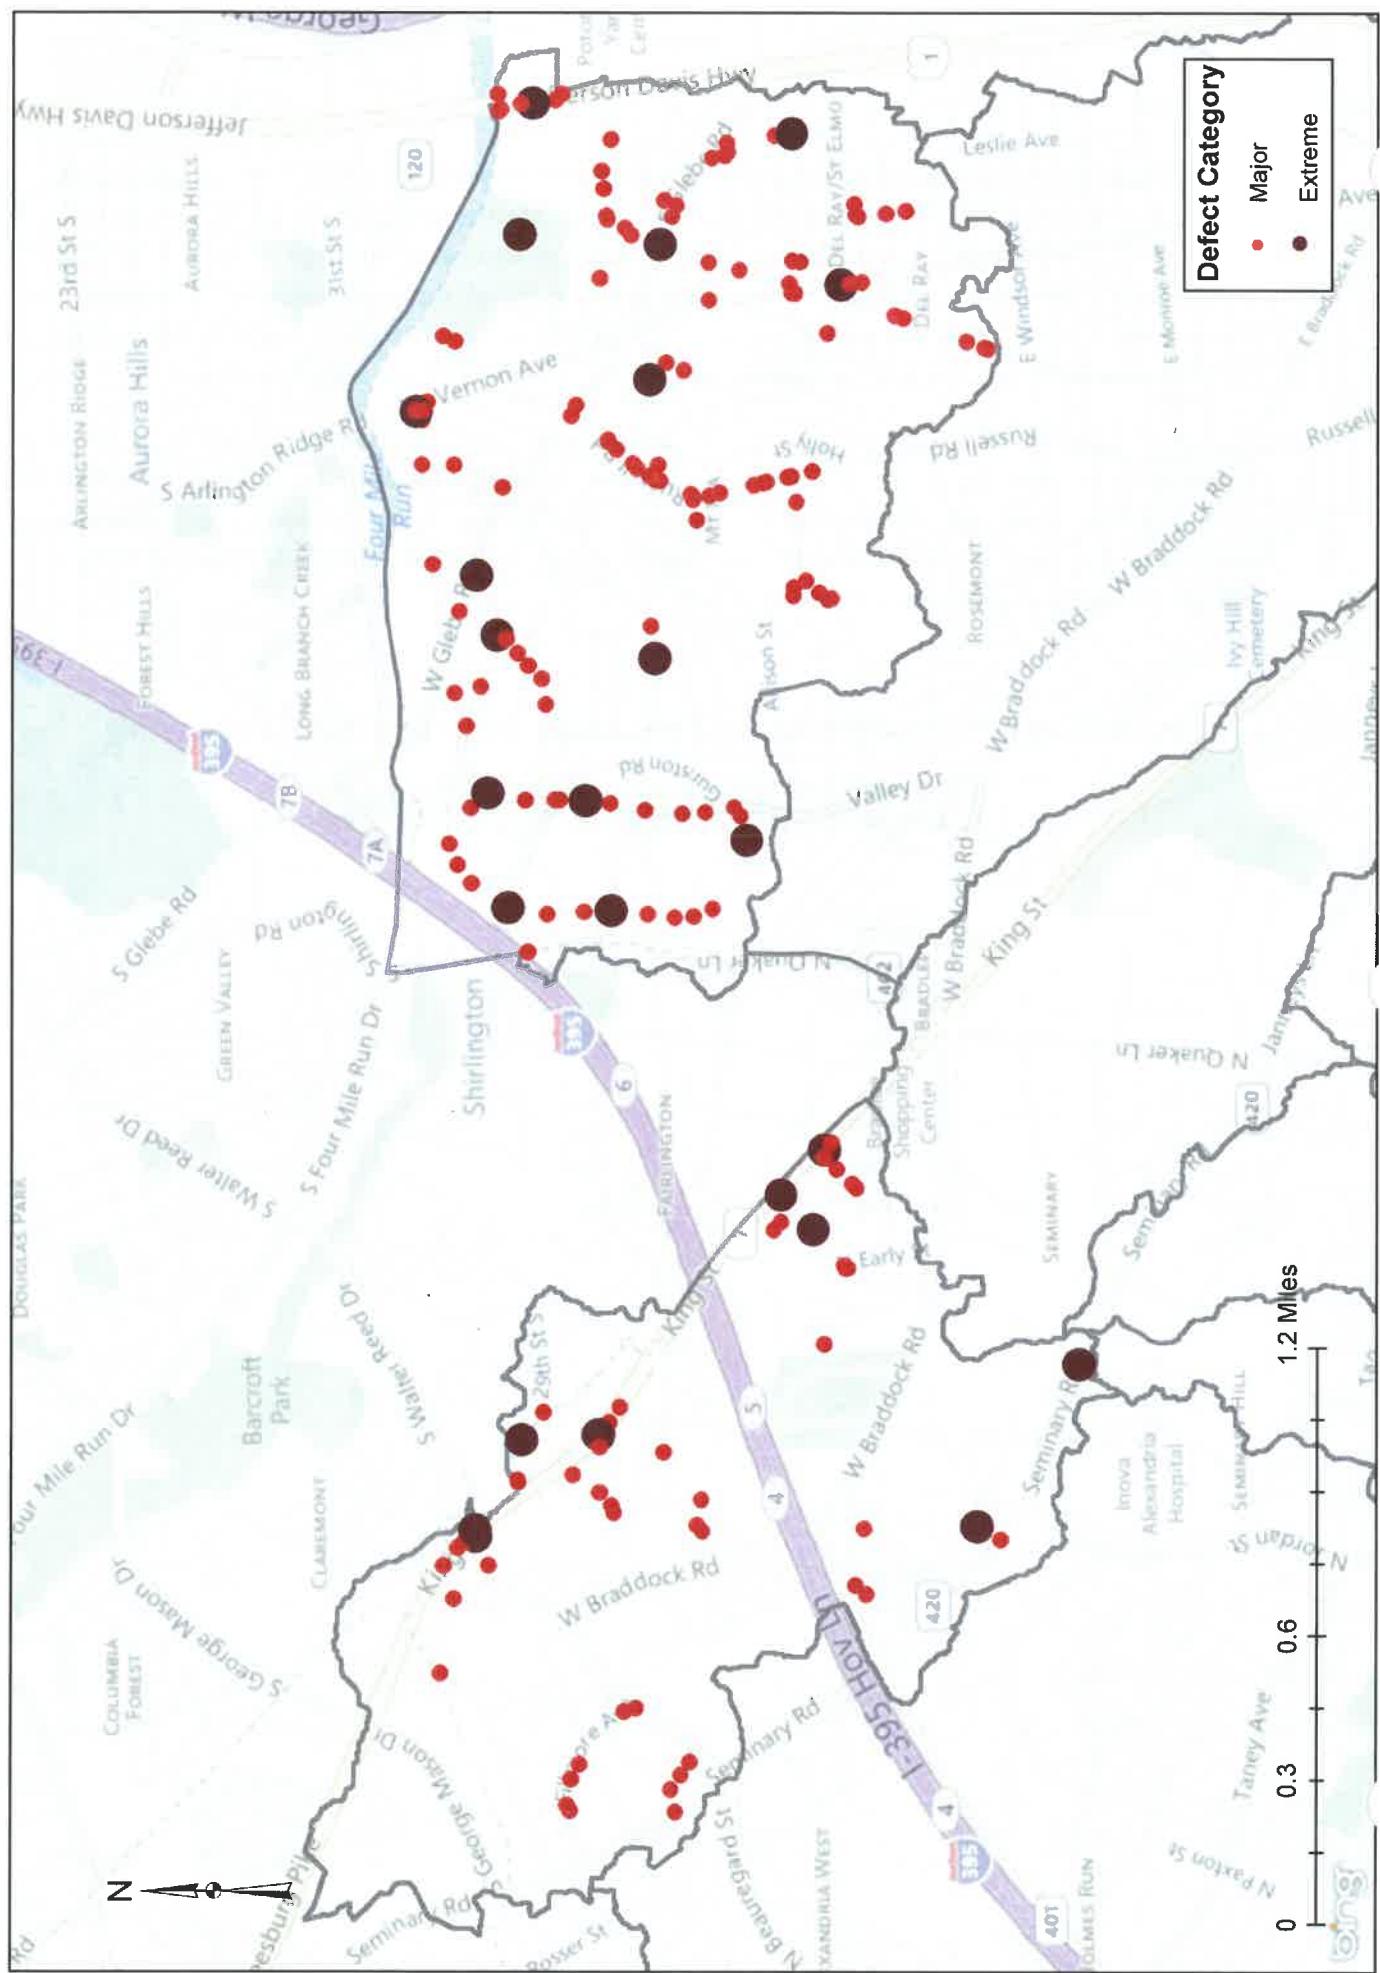
Figure 3. Location of Storm Structures in the "Major" and "Extreme" Categories (Color coded by Severity of Defects).

Figure 3 displays the location of the structures classified with major and extreme damage only. In the east side of the Four Mile Run watershed, the corridors of Martha Custis Drive, Valley Drive, Russell Road, and Commonwealth Avenue seem to have clusters of structures with high defect scores. The western side of the watershed seems to have fewer patterns, though there are some clusters along King Street and at the intersection with Beauregard Street. Appendix A: Structure Inspection Summary provides a breakdown of the observed defects and the SCREAM defect score of each storm structure.

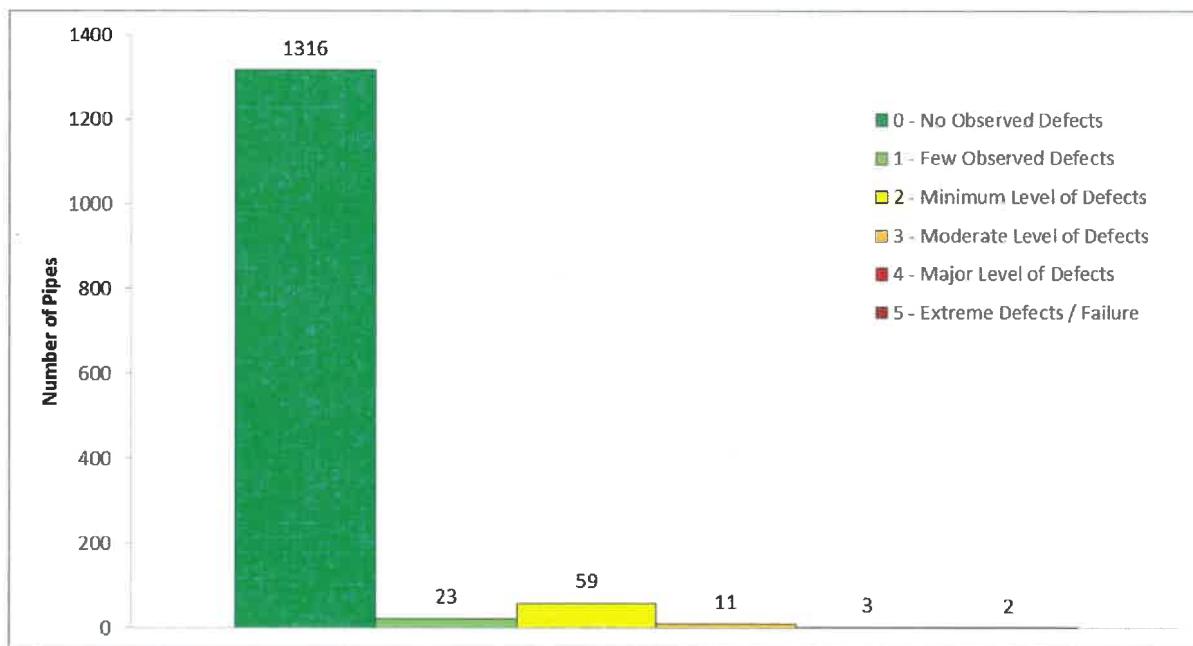
Figure 5. Pipe Lamping Inspection Summary.

Figure 5 is a summary of the inspection results by severity of the pipe defect, and Figure 6 shows the location of each inspected pipeline, color coded by defect severity. The average condition score of 1,414 storm pipe segments inspected within the Four Mile Run watershed area was 2.5 (Few). Inspection results in Four Mile Run showed that the pipe segments were generally in excellent condition, with 93% of the pipes exhibiting no defects. Twenty-three (23) segments fell within the “few” defect category, 59 segments in the minimum category, and 11 in the moderate defect category. These kinds of defects include circumferential or longitudinal cracks, infiltration evidence, minor joint separation, and small root intrusions. Five (5) pipes with more severe defects (scores 61 and up) suffered problems such as multiple cracks, significant infiltration, open or offset joints, or broken pipes. Two (2) pipes had extreme damage (score of 100): one pipe was filled with debris, and the other was collapsed. Figures 7 and 8 are images from the inspections.
